MILLER POND DAM

NDI NO. PA-00159

**PHASE I INSPECTION REPORT
NATIONAL DAM INSPECTION PROGRAM**

Name of Dam: MILLER POND DAM, NDI NO. PA-100159
State & State No.: PENNSYLVANIA, 64-39
County: WAYNE
Stream: TRIBUTARY TO JOHNSON CREEK
Date of Inspection: October 24, 1979

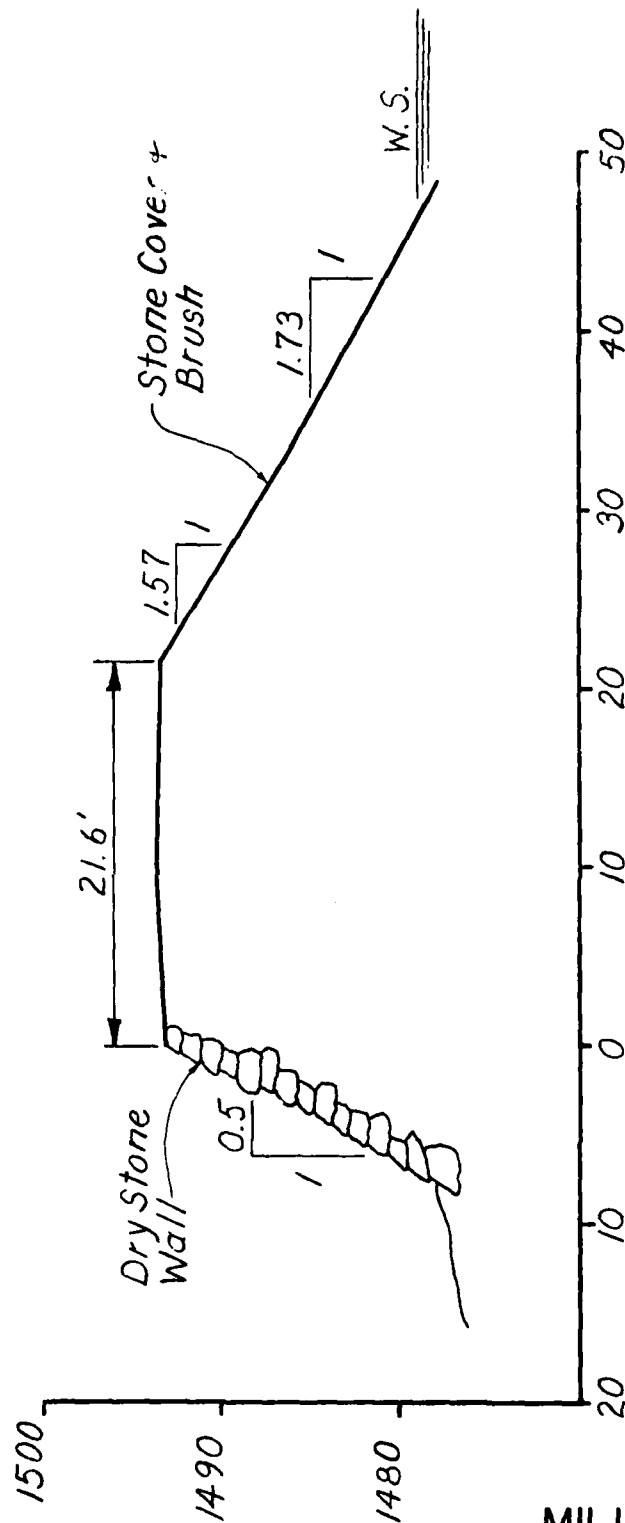
MILLER POND DAM
 PA.-00159
 INSPECTION SURVEY
 PLATE A-III

The upstream slope of the embankment is rather steep (see Plate A-III) and has a considerable growth of brush. The slope is covered with loose stone and appears to be stable. At the left end of the embankment is a low area (refer to profile Plate A-II, Appendix A). The top of the dam is well maintained. The downstream section of the dam consists of a loose, handlaid dry stone wall with a slope of about 0.5H to 1V. The wall appears to be sound. Evidence of seepage was not detected. About twenty feet to the left of the outlet structure, a small depression was noticed in front of the wall. This depression has been there for many years.

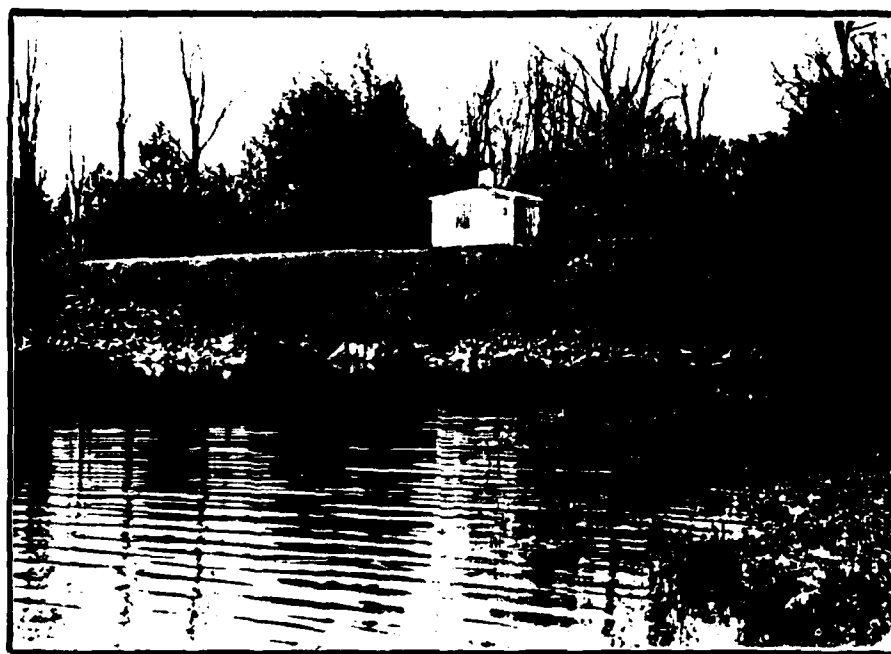
The entrance conduit to the wetwell is under water and could not be inspected. A concrete headwall is visible, but it is unknown how far the concrete lining is extended and in what condition it is. The wet well and stoplogs appeared to be in good condition as was the outlet conduit. This conduit has a concrete base with stone walls and arch.

UPSTREAM SLOPE - NOTE CONCRETE CONDUIT HEADWALL - NO. 3

1. That the upstream end of the outlet tunnel be inspected.
2. That the downstream section of the outlet conduit be inspected on an annual basis for possible deterioration of the concrete floor.
3. That all brush be removed from the embankment and that the downstream face of the stone wall be kept clear of growth.
4. That a formal surveillance and downstream warning system be developed to be used during periods of heavy or prolonged precipitation.
5. That a program be developed for regular inspection and maintenance.

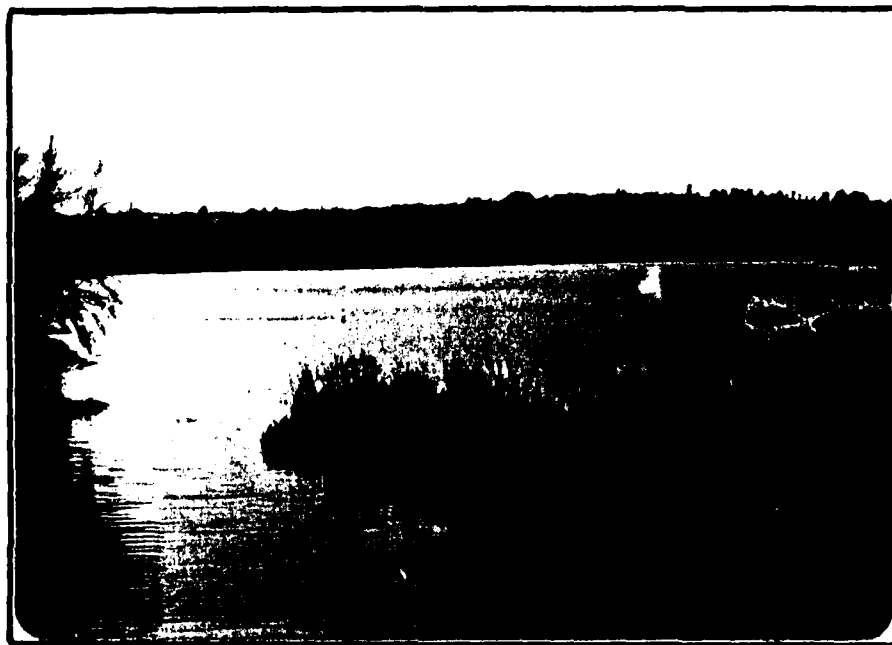
PA-00159
Plate C-IV

The area around the reservoir is mostly wooded with relatively flat slopes. The slopes are stable. Excessive siltation in the reservoir has not been a problem.

RESERVOIR AREA - NO. 6
